Quality Assurance Inspection Report

Building 5 Foundation Stabilization

5100 Village View Way

Subject: Quality Assurance Construction Observation Summary
Foundation Stabilization – Building 5
Village View Way, Missoula, Montana

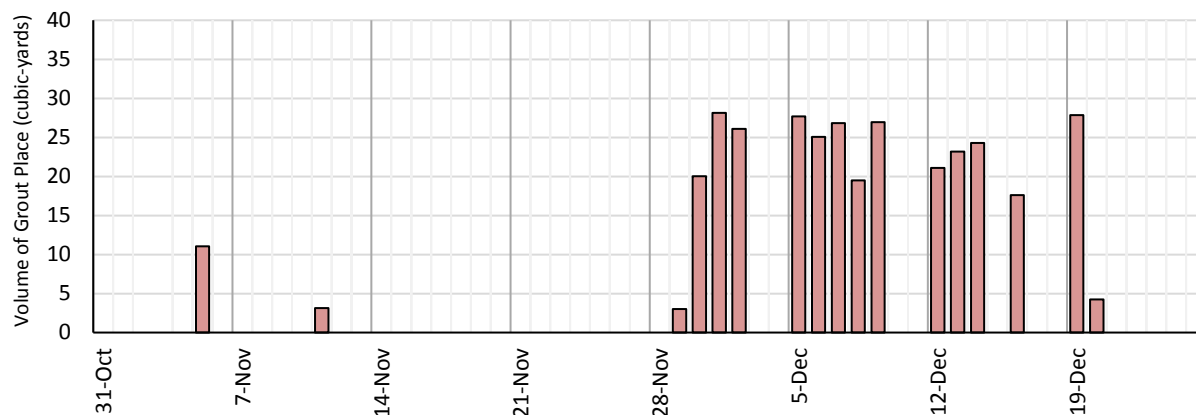
Figure 1 - Summary of LMG Column Production

Hayward Baker began installing casing on November 4, 2016 throughout building 6 in preparation of constructing low-mobility grout (LMG) columns, which began subsequently on November 5. These initial columns were constructed to verify subsurface conditions and grout volumes. Construction on building 5 began after the completion of building 6 on November 29. The coring of concrete slab, driving of casing, and injection of LMG continued concurrently until the completion of the last column on December 20, taking less than 4 weeks to complete. Figure 1 below summarizes the quantity of grout injected by date.

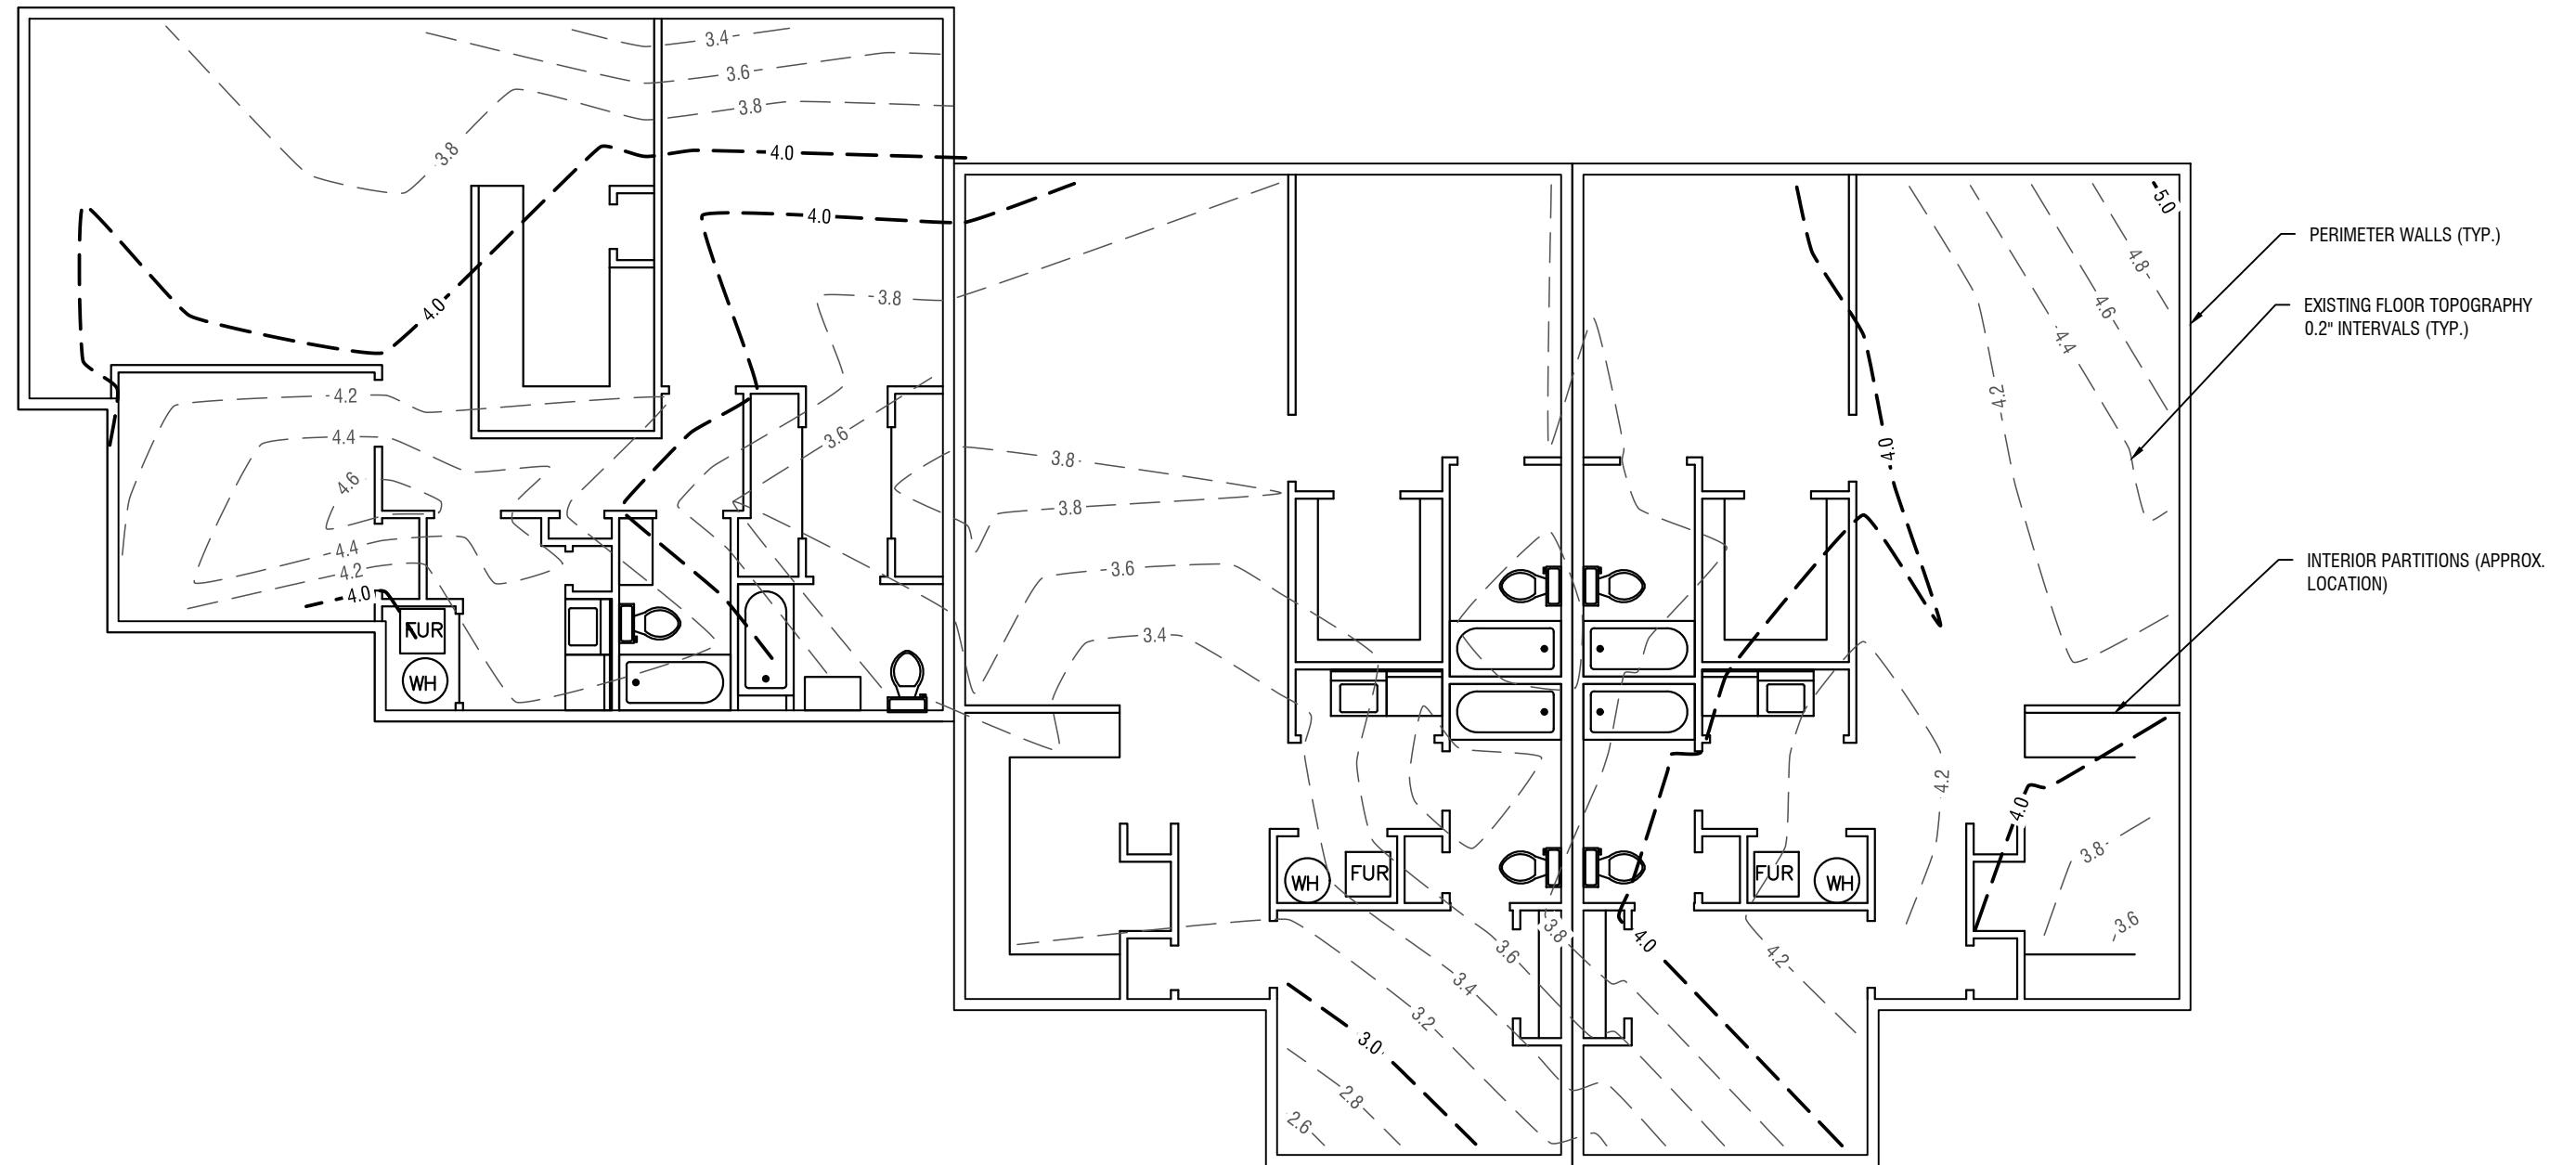
2013 FLOOR TOPOGRAPHY - BUILDING 5
Geotechnical Foundation Investigation
Village at Elk Hills Homeowner's Assoc.
5100 Village View Way, Missoula, Montana
05 02 13 Project: 13009 Drawing 2 / 5

Prior to stabilization, the differential settlement of Building 5 was moderate with elevation difference on the main slab-on-grade floor (in the living area) ranging from 0.6-inches in unit 5-3 to 2.4-inches at the east end of units 5-1 and 5-2. See the attached drawing “2013 Floor Topography – Building 5.” The 2013 survey did not include attached garages.
